A Red Light Running (RLR) Photo Enforcement System was installed at the intersection of 5th Avenue at IL Rte. 64 (North) on December 3, 2007, after finding limited success with other attempted measures to promote safer driving and improve compliance with traffic laws. The following statistical analysis was performed through 2015. Calendar year 2016 was not included as the Illinois Department of Transportation (IDOT) has not yet completed collecting all data. The statistical analysis will be updated annually, as collected data becomes available from IDOT.

5th Avenue at IL Rte. 64 (North)
Melrose Park, IL

- RLR Photo Enforcement System monitors violations occurring on the eastbound and westbound approaches of the intersection
- RLR Photo Enforcement System installed: December 3, 2007

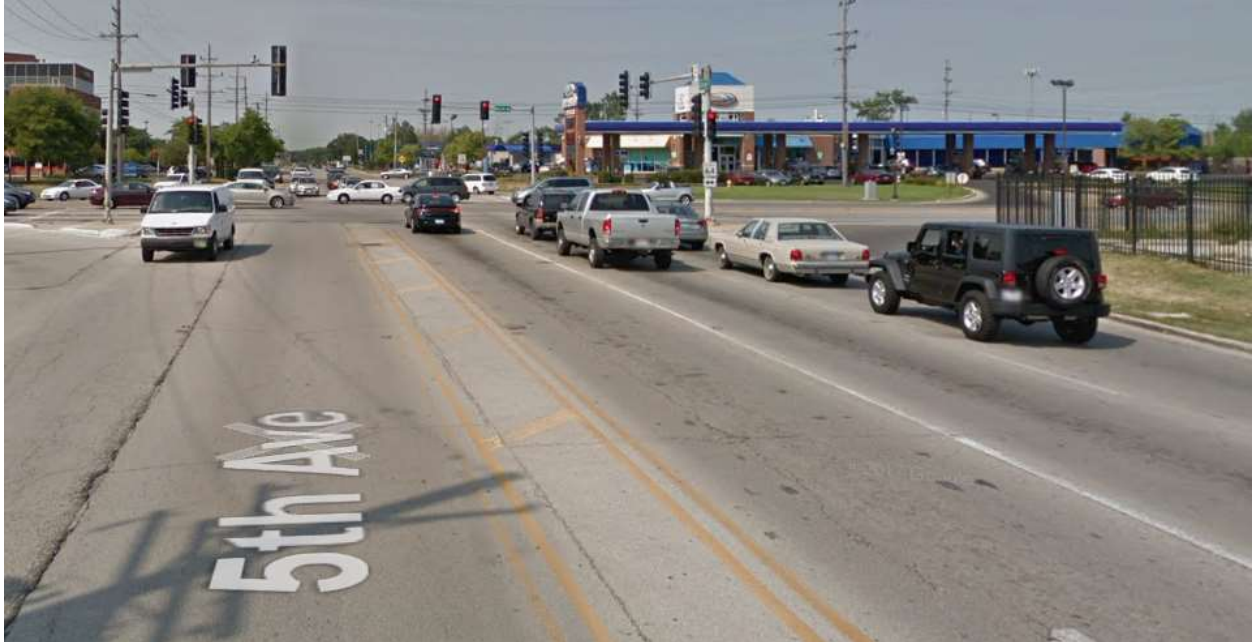
5th Avenue at IL Rte. 64 (North), Northbound Approach

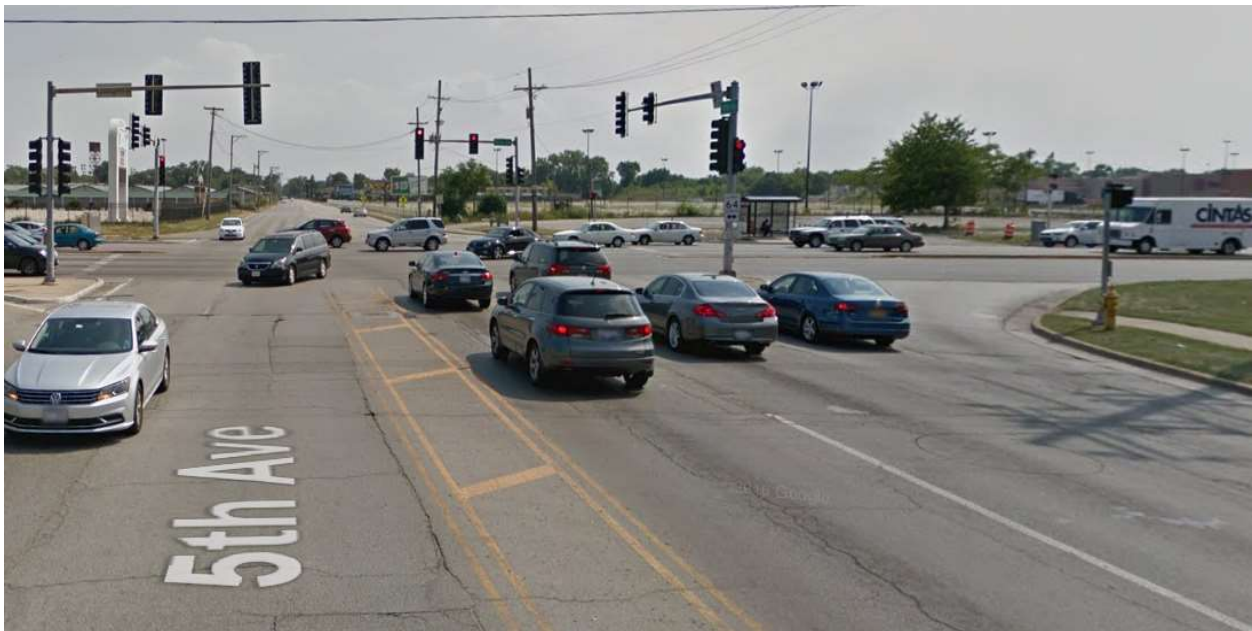
5th Avenue at IL Rte. 64 (North), Southbound Approach

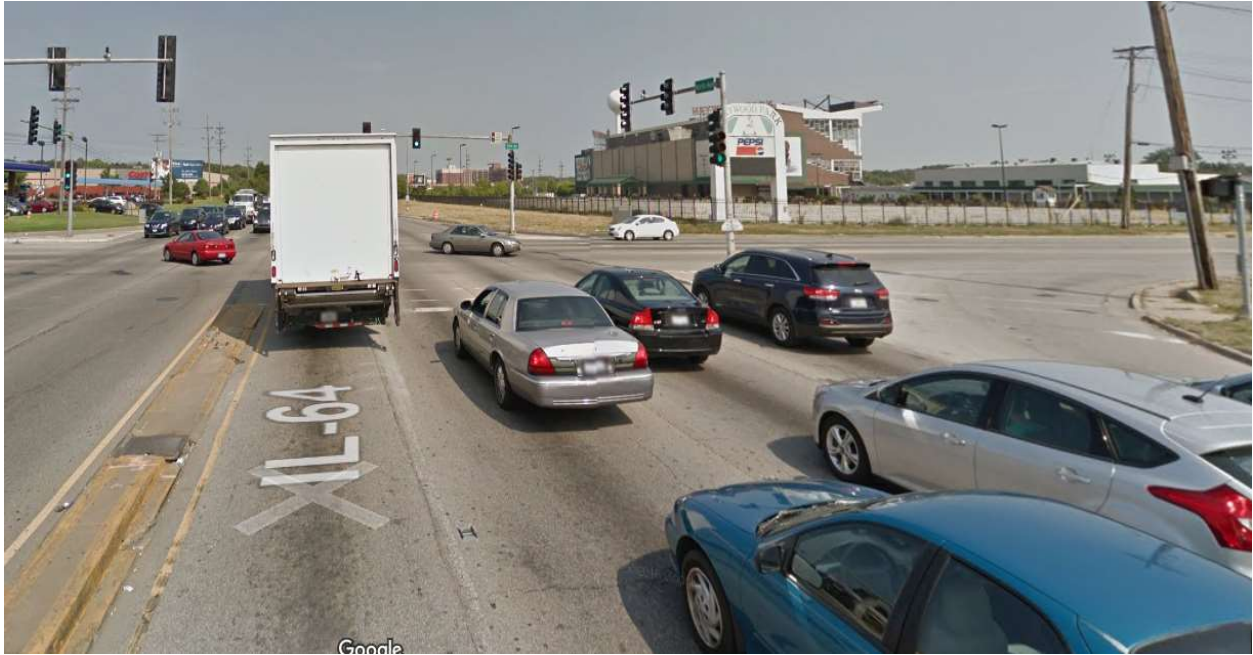
5th Avenue at IL Rte. 64 (North), Westbound Approach
